Instrumentation and Monitoring of Mahawewa Landslide off Walapane in Central Hills of Sri Lanka

Abstract: *As instability of the slope area at Mahawewa, Walapane has been identified as a major threat to the people since 1986, National Building Research Organization has started a project of monitoring and stabilization of the slope, cooperating with the Japan International Cooperation Agency in 2010. Main involvement of this study was to do the instrumentation and monitoring, mainly based on analysis of un-stabilization parameters of the area which measured using five instruments. That is horizontal movement at sub surface using Inclinator, fluctuation of ground water level using piezometers, characteristics of slip surfaces using strain gauges, movement of the surface using extensometers and rainfall using rain gauges. In addition to above drill log data of the site, visual information of cracks generated and springs available were also used. Finally, according to the results of analysis the unfavourable ground water level in slope area has been identified as the most critical factor of the landslide. According to that conclusion a suitable mitigation options for Mahawewa landslid

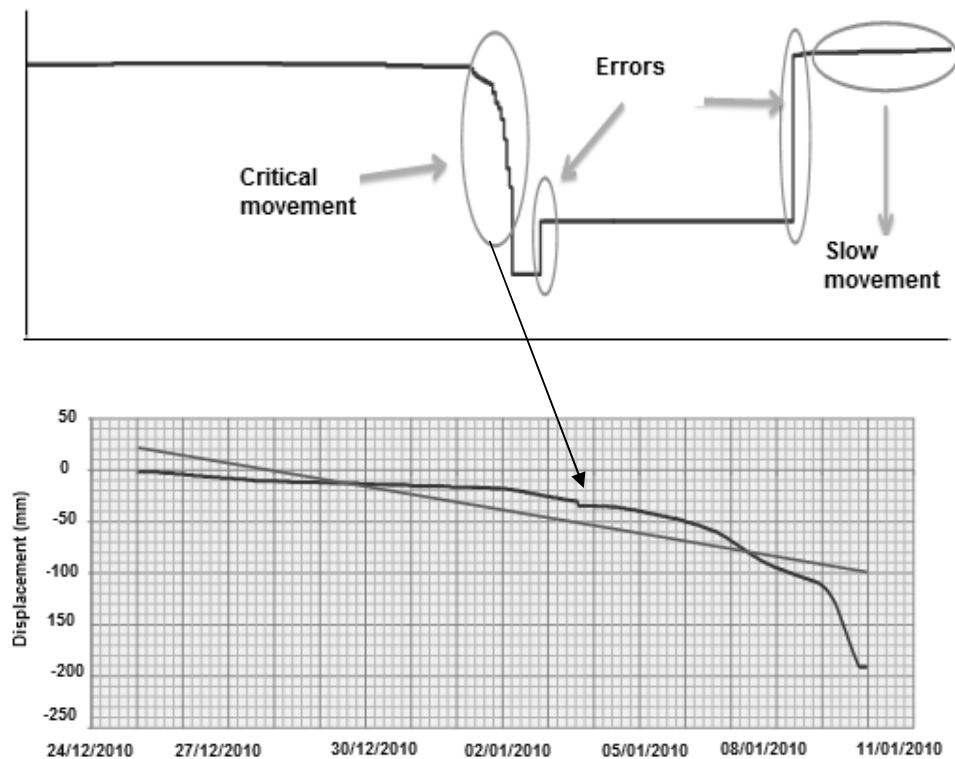
Figure 2 Analysing of surface displacement

As it provides the relative movement between two points on the sliding body the readings were plotted against the time to realize the continuous movement during a considered time period. Then it was compared with the rainfall as it is the main driven force of all most all the landslides in Sri Lanka. Then regarding those graphs the particular sections which indicate rapid movements were further analysed. The errors identified were removed to clear visualization of the critical movement (Fig 2).

In here with the help of a trend line, an equation was obtained in the format of " $y = Mx + C$ ". It gives a relationship between movement and time. Then the value received for the "M" indicates the rate of movement (mm per Day) while the sign mark (+,-) indicates the direction of movement. If a mines sign is received it indicates that the lower part is moving fast and vice versa.

- **Ext 01:** Critical movement - 25/12/2010 to 10/01/2011. Lower portion from the Crack has relatively moved downward. Rate of movement is 7.56 mm per day.
- **Ext 02:** Critical movement- 08/12/2010 to 09/01/2011. Rate of movement is 3.629 mm/day. Lower portion from the major boundary has moved downward.
- **Ext 03:** Critical movement- 25/11/2010 to 09/12/2010. Rate of movement is 17 mm/day. Lower portion from the crack has relatively moved downward.
- **Ext 04:** Critical movement- 27/11/2010 to 27/12/2010. Rate of movement is 1.3 mm/day. Low downward movement compare with the other movements.

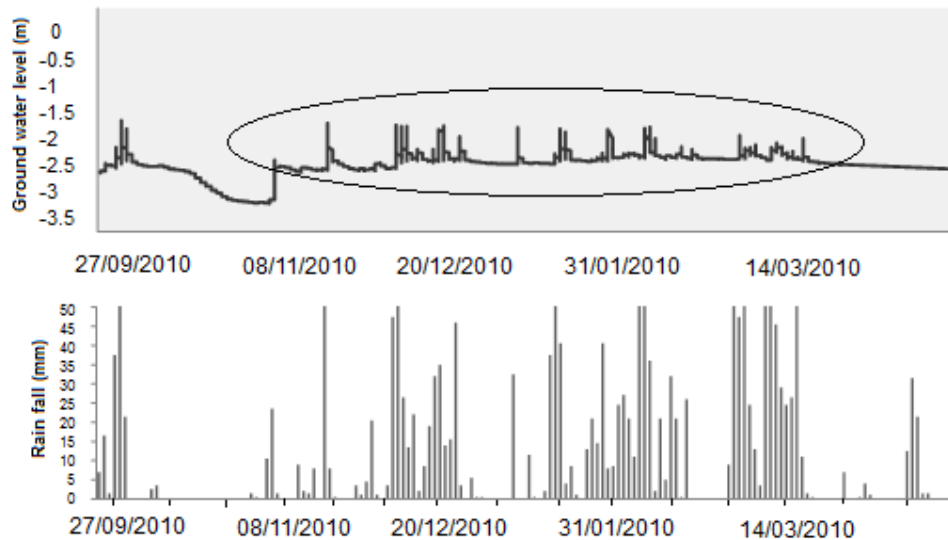
Figure 3 Groundwater level with the rain

As this diagram indicates groundwater level has been rapidly changed during the rainy season. It means that water get accumulated within the slope area which cause to increase the hydraulic pressure and reduce the factor of safety. To have a much accurate result upon ground water the data obtained from water gauge was also referred.

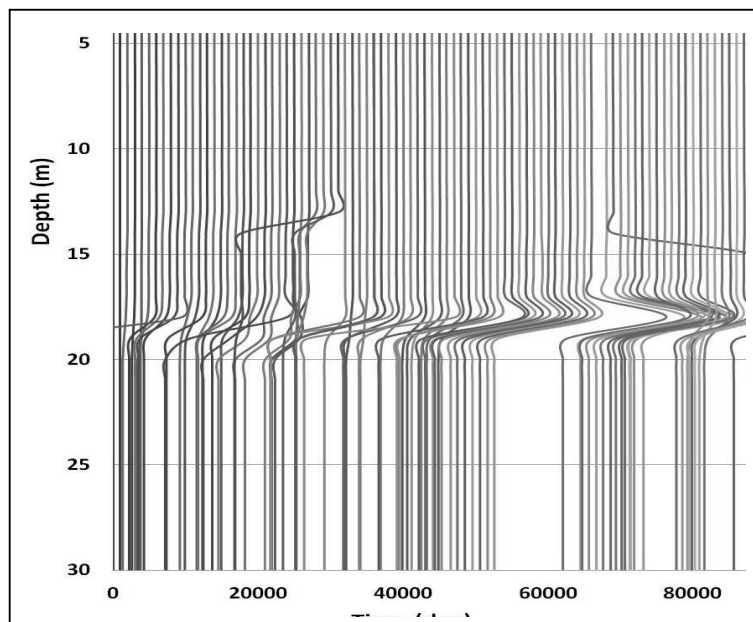
Figure 4 Identification of slip surfaces – Strain Gauge data

At the Mahawewa slope there are two strain gauges are installed and it provides the valuable result of depth to the potential slip surfaces. At first Strain Gauge data were plotted and identified some rapid changes (Fig 4). For having such a huge strain changing, there should be critical failures at the corresponding depth.

First 6 months – Mainly two slip surfaces were identified at 13 m and 18 m depth below the location of SG2 (Fig 8). The slip surface at 13 m depth also can be detected at the 11 m depth below the SG1. This has a slow movement with the rain. The effect is varying up to 1m above the slip surface and varies with the rain fall.

Slip surface at 18 m depth below the SG2 has a rapid movement in whole time period which concerned. It has affection area of 1 m above the slip surface and 2 m below the slip surface. That affection area range is changed with the rain fall and continued the same in dry season.

Second 6 months – New two slip surfaces are formed in shallow area with the depth of 4m and 10m below the SG2

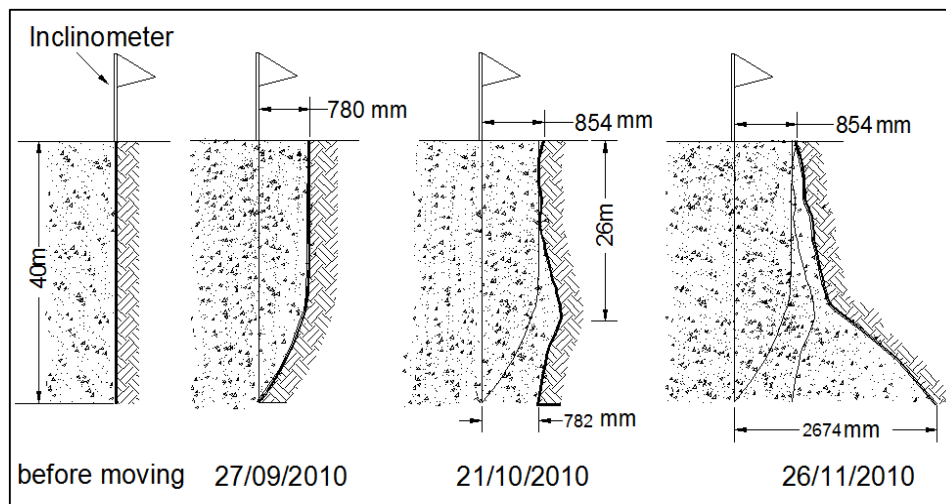
Figure 5 Results of Inclinator

As strain gauge data is not sufficient for correctly defining the slip surfaces, the Inclinator data also has been used. That represents the horizontal movement in sub surface below the location of Inclinator. Those movements are always measured with respect to the end point of the inclinometer bore hole. Those movements are shown in below (Fig 5) and it gives an idea of occurring of a slip surface at 26m depth below the particular location.

In here the end point of the Inclinator is also have a considerable horizontal movement. It can be happen only if there are slips surfaces occurring bellow the end point of the Inclinator. Then gives an idea about availability of slip surfaces even bellow the 40m depth from the location of Inclinator. All the analysed data about potential slip surfaces in first 6 months which were taken from two strain gauges at the middle area and from 1 Inclinator at top of the slope is summarised as follows (Fig 6, Fig 7).

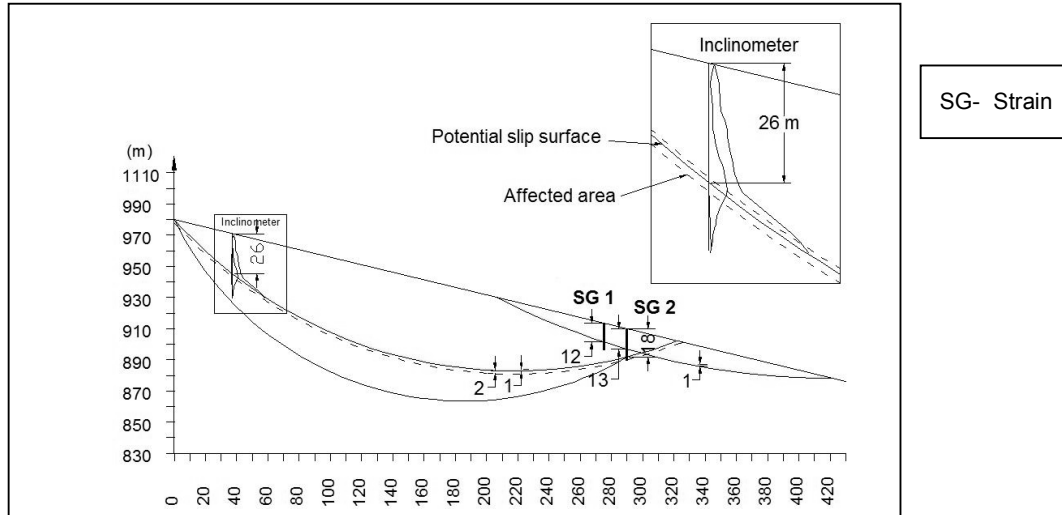
Figure 6 Potential Slip Surfaces at the Mahawewa slope (24/07/2010 to 10/01/2011)

According to the monitoring data, the type of this Mahawewa landslide is a debris rotational slide, and also rock falling can be seen only at the top of the landslide. Mainly four slip surfaces could be identified and there is a possibility to have another deep slip surface below the 40 m depth of Inclinator station.

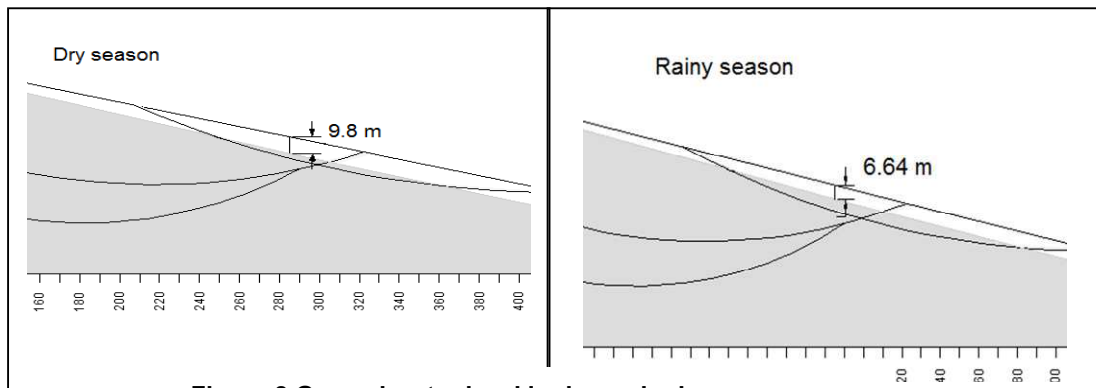
Figure 8 Ground water level in dry and rainy seasons

- Top of the slope – at 2.5 m depth
- Middle area of the slope – 9.82 m depth

- Top of the slope – at 1.75 m depth
- Middle area of the slope – 6.64 m depth

However the most critical factor of this landslide is the unfavourable ground water level in slope area. It has been clearly identified that in dry season Piezometer indicates the average ground water level of 2.5 m at the top of the slope and Strain Gauges indicate average ground water level of 9.82 m at the middle area of slope moving axis. In rainy season at the top of the landslide ground water level has been reduced up to 1.5 m level while middle axis of the slope has 6.64 m ground water level. Then it can be concluded that the ground water level is always above the critical slip surfaces even in dry season. So it is better to reduce the water column well below the deepest critical slip surface.

But it is not feasible as well as practicable to establish such a process to reduce the water level completely below the main critical failure surfaces. Then it is suitable to minimize the effect of the water column by reducing the water level down to some optimum extent. Then the weight component of this unfavourable water column is minimized and hence the safety factor can be increased.

Temporally mitigation options also can be used to minimizing the rate of ground displacement of the slip surfaces while introducing proper water proof sealing techniques for the prevention of water entering to the surface cracks. Introducing of well maintaining ditches system is essential. Then can minimize the amount of water accumulated in the abandon reservoir area up to some extent. It also can be performed by designing a surface drainage system of diversion channel system to the top of the landslide to divert the direct water entries from the escarpment which cause to reduce the erosion of the slope.

Not only surface drainage system but also subsurface drainage system can be introduced to remove the accumulated excess water in abounded lake and sliding area. Inserting horizontal or vertical drains are preferred. Furthermore, to increase the feasibility of the project, extracted water can be utilized for the benefit of the people living around Kumbalgamuwa area. For instant surface water can be used for the agricultural activities while using the subsurface water for drinking purposes.
